SUBMITTED BY/EINGEREICHT VON: PAUL MASCHINENFABRIK

Optical inspection of button heads on prestressing steel

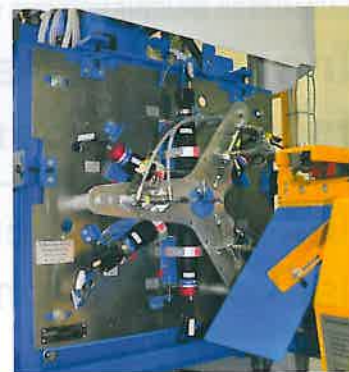
Figure: Paul

A camera system with advanced image processing positioned directly downstream of the button-heading machine automatically detects geometric errors and cracks

Direkt hinter der Kopfstauchmaschine erkennt ein Kamerasystem mit moderner Bildverarbeitung automatisch Geometriefehler und Risse

A camera system with advanced image processing stationed directly downstream of the button-heading machine automatically detects geometrical faults and cracking on the button-heads. The system inspects every head within approx. 10 seconds. During this period, it positions and fixes the prestressing steel, and several cameras take two pictures each with different lighting. Following evaluation of the pictures, faultless button-headed tendons are passed on to the subsequent processes, and faulty button heads are automatically cut off, together with 10 cm of wire, and are disposed of.

mit moderner Bildverarbeitung automatisch Geometriefehler und Risse an den gestauchten Köpfen. Das System überprüft jeden Kopf in rund 10 s. In dieser Zeit positioniert und fixiert es den Spannstahl, mehrere Kameras erstellen jeweils zwei Aufnahmen mit unterschiedlicher Beleuchtung. Nach der Bildauswertung werden fehlerfreie gestauchte Drähte an den Folgeprozess übergeben, fehlerhafte Köpfe werden mit 10 cm Draht automatisch abgeschnitten und entsorgt.
